# Accident Analysis

## 3.1 THE PHYSICAL CAUSE

The physical cause of the loss of *Columbia* and its crew was a breach in the Thermal Protection System on the leading edge of the left wing. The breach was initiated by a piece of insulating foam that separated from the left bipod ramp of the External Tank and struck the wing in the vicinity of the lower half of Reinforced Carbon-Carbon panel 8 at 81.9 seconds after launch. During re-entry, this breach in the Thermal

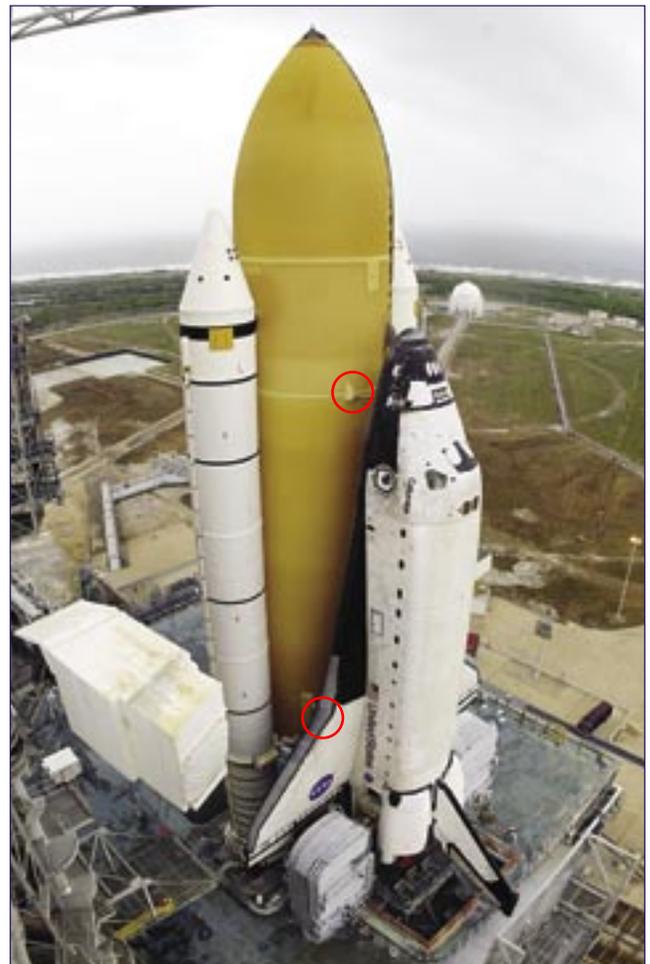
Figure 3.1-1. Columbia sitting at Launch Complex 39-A. The upper circle shows the left bipod (-Y) ramp on the forward attach point, while the lower circle is around RCC panel 8-left.

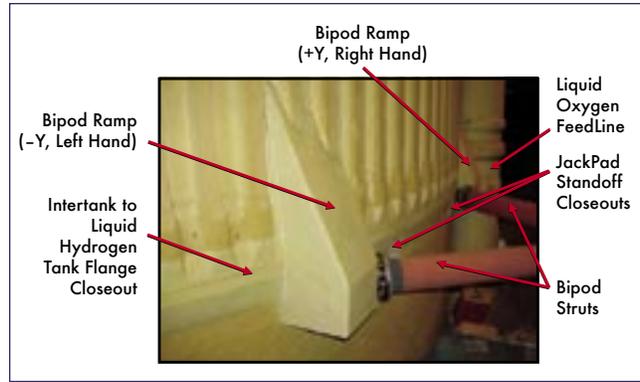
Figure 3.2-2. The exterior of the left bipod attachment area showing the foam ramp that came off during the ascent of STS-107.

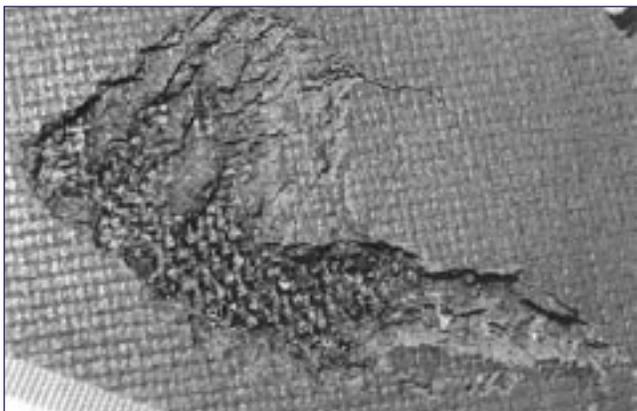
Figure 3.3-2. Damage on the outer surface of RCC panel 10-right from *Atlantis* after STS-45.

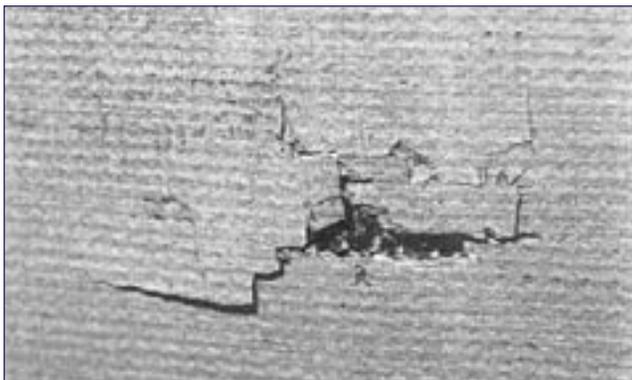
Figure 3.3-3. Damage on the inner surface of RCC panel 10-right from *Atlantis* after STS-45.

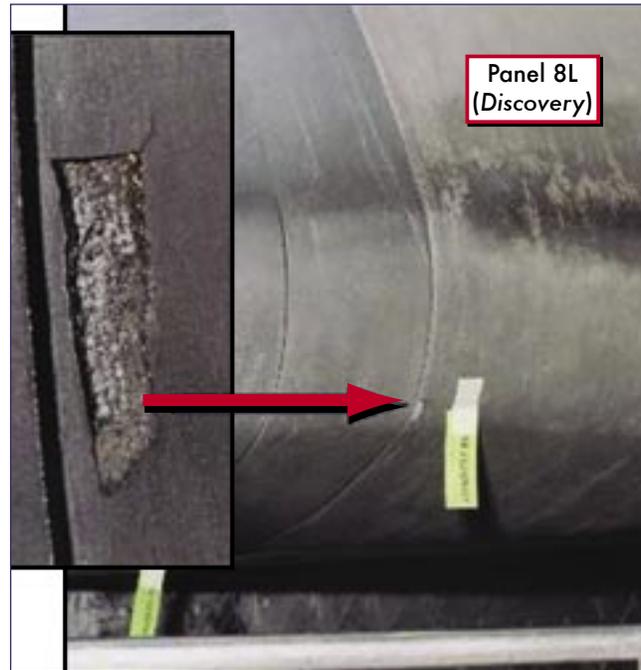
Figure 3.3-5. RCC panel 8-left from *Discovery* had to be scrapped after STS-103 because of the damage shown here.

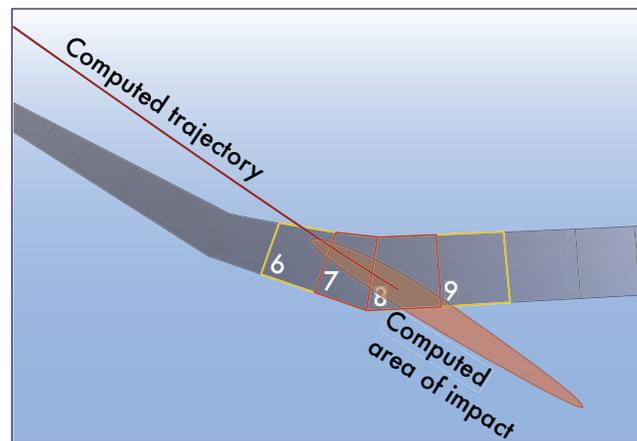
Figure 3.4-3: The best estimate of the site of impact by the center of the foam.

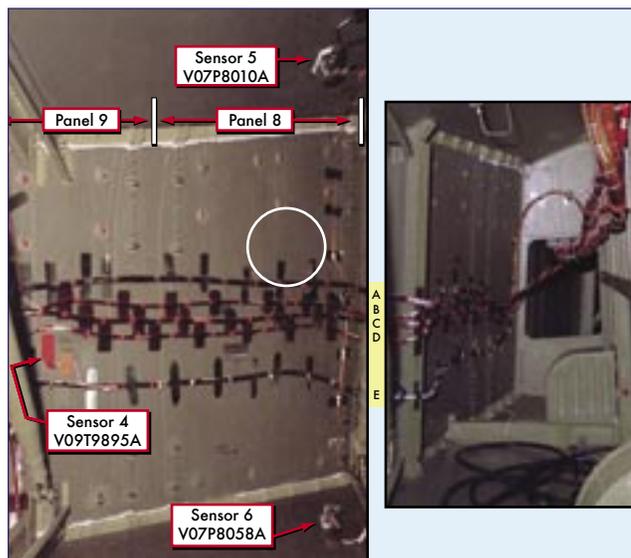
Figure 3.6-8. The left photo above shows the wiring runs on the backside of the wing leading edge behind RCC panel 8 – the circle marks the most likely area where the burn through of the wing leading edge spar initially occurred at EI+487 seconds. The right photo shows the wire bundles as they continue forward behind RCC panels 7 and 6. The major cable bundles in the upper right of the right photo carried the majority of the sensor data inside the wing. As these bundles were burned, controllers on the ground began seeing off-nominal sensor indications.

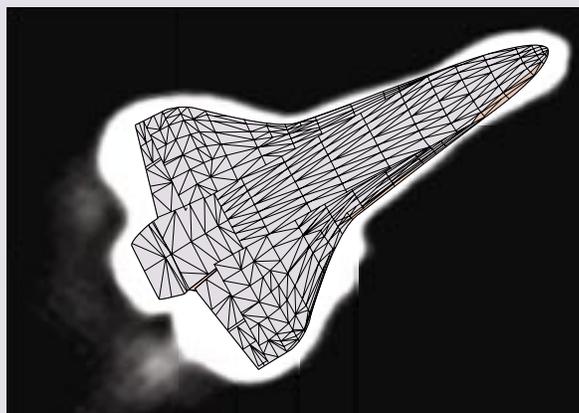
The image shows an unusual condition on the left wing, a leading-edge disturbance that might indicate damage. Several analysts concluded that the distortion evident in the image likely came from the modification and interaction of shock waves due to the damaged leading edge. The overall appearance of the leading-edge damage at this point on the trajectory is consistent with the scenario.

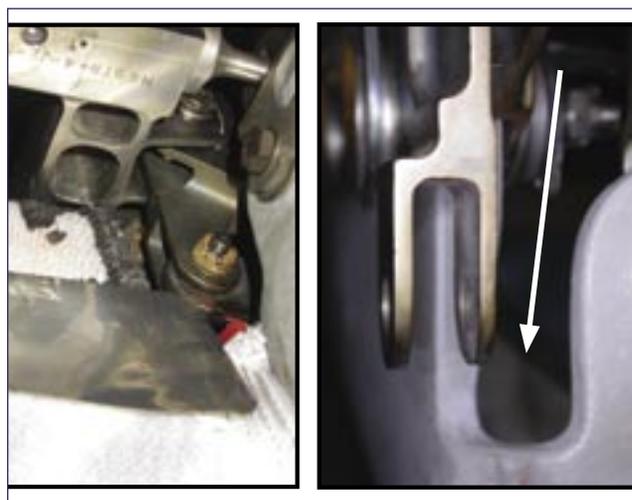
Figure 3.7-2. Each RCC panel has a U-shaped slot (see arrow) in the back of the panel. Once superheated air entered the breach in RCC panel 8, some of that superheated air went through this slot and caused substantial damage to the Thermal Protection System tiles behind this area.

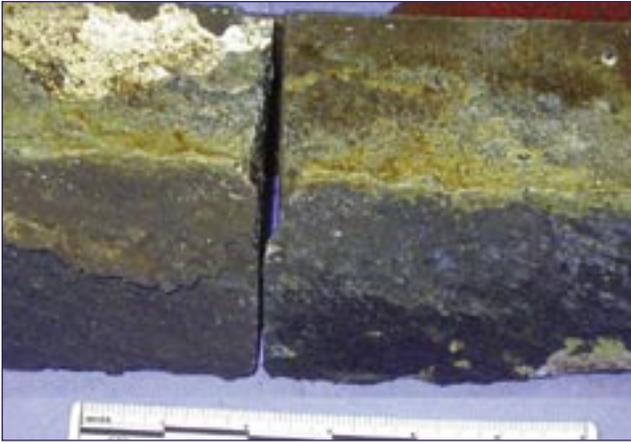
Figure 3.7-3. Superheated airflow caused erosion in tiles around the RCC panel 8 and 9 interface. The tiles shown are from behind the area where the superheated air exited from the slot in Figure 3.7-2. These tiles showed much greater thermal damage than other tiles in this area and chemical analysis showed the presence of metals only found in wing leading edge components.

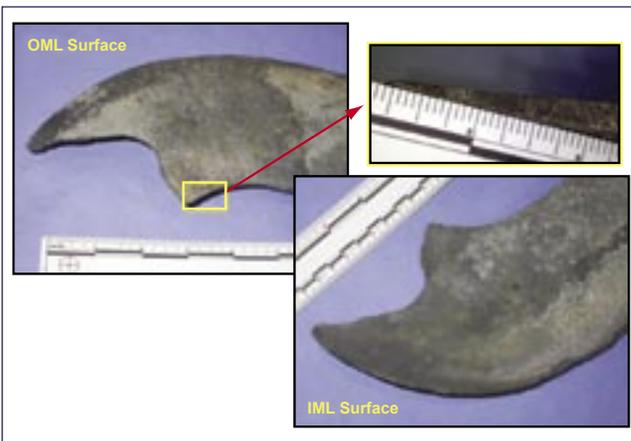
Figure 3.7-4. The outboard rib of panel 8 and the inboard rib of panel 9 showed signs of extreme heating and erosion. RCC erosion of this magnitude was not observed in any other location on the Orbiter.

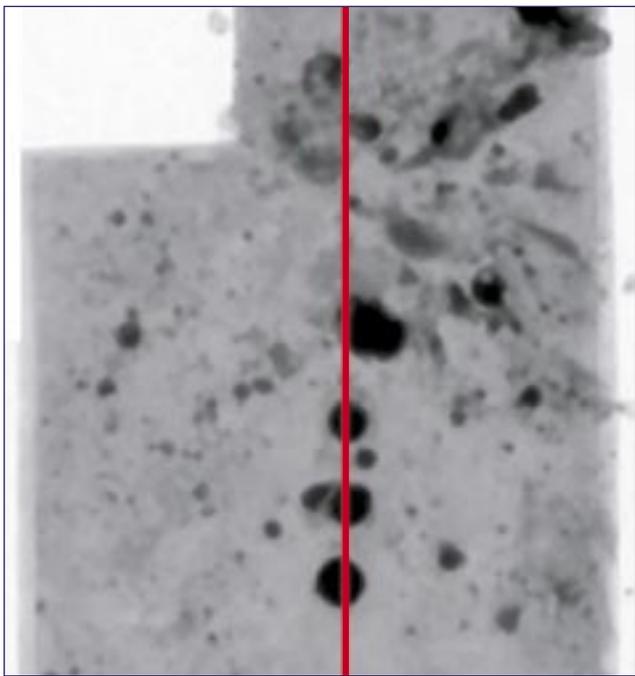
*Figure 3.7-7. X-ray analysis of RCC panel 8-left showed a bottom-to-top pattern of slag deposits.*

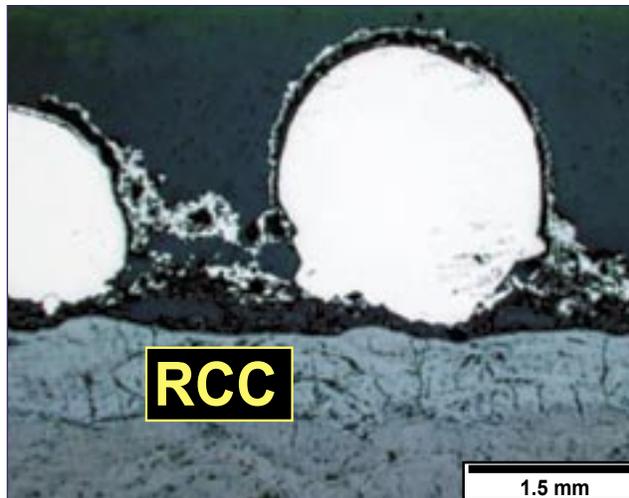
*Figure 3.7-8. Spheroids of Inconel 718 and Cerachrome were deposited directly on the surface of RCC panel 8-left. This slag deposit pattern was not seen on any other RCC panels.*

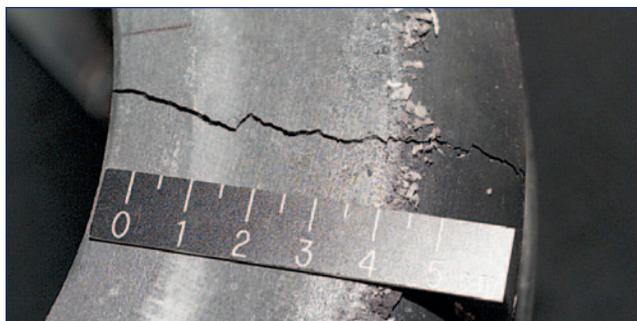
Figure 3.8-6. A 5.5-inch crack on the outboard portion of RCC Panel 6 during testing.

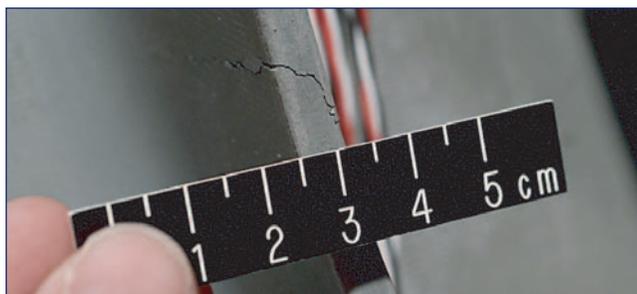
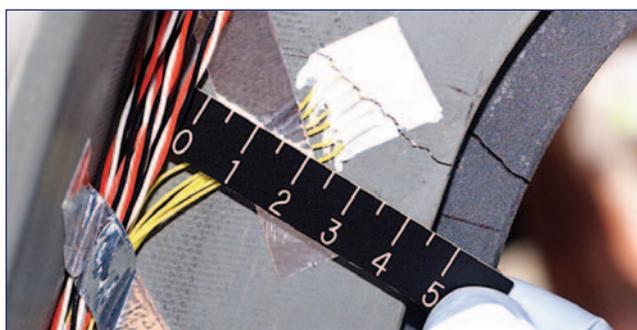
Figure 3.8-7. Two views of the crack in the T-seal between RCC Panels 6 and 7.

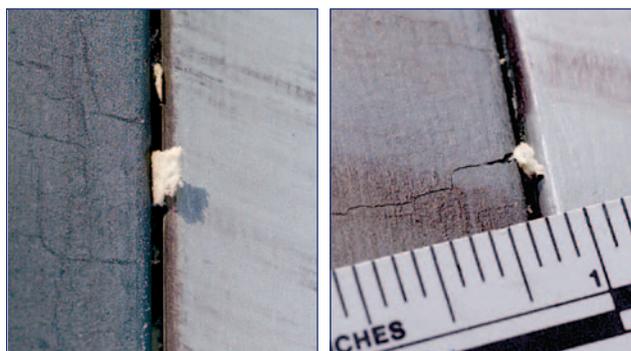
Figure 3.8-8. Two views of foam lodged into the slit during tests.

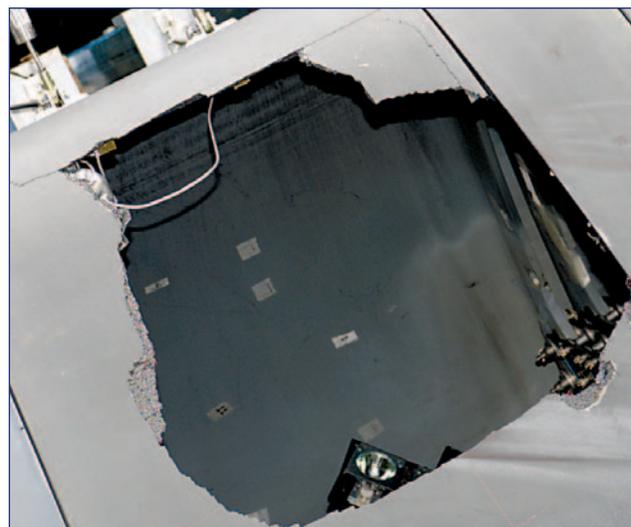
Figure 3.8-9. The large impact hole in Panel 8 from the final test.

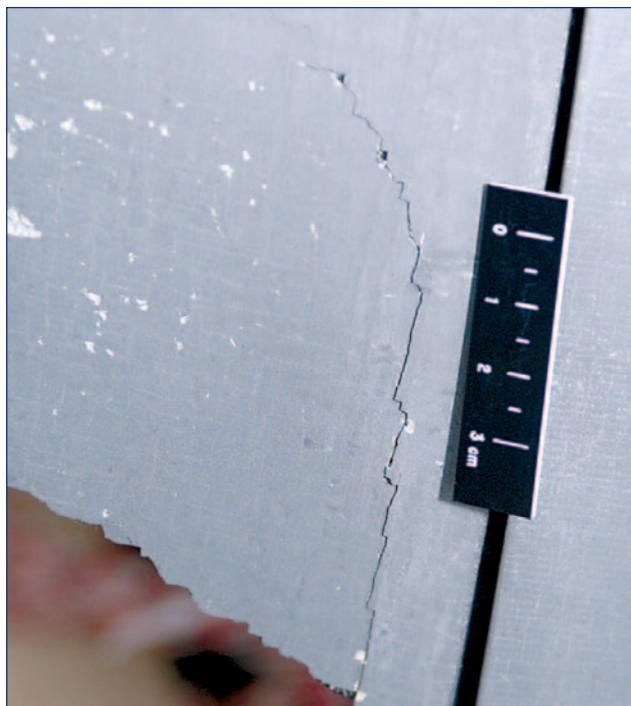
Figure 3.8-10. Numerous cracks were also noted in RCC Panel 8.

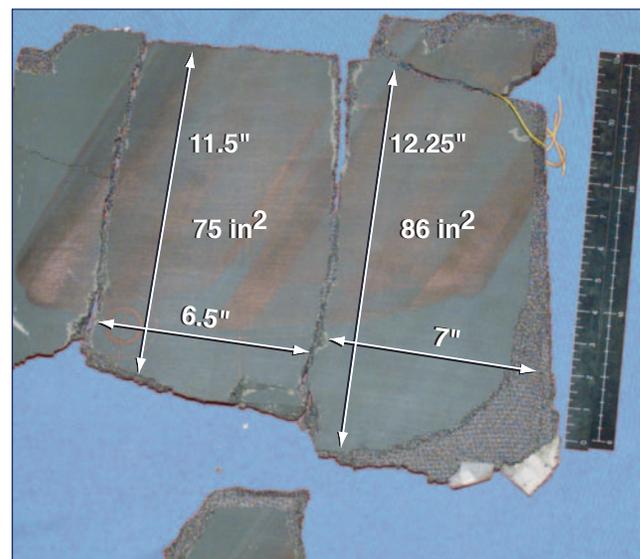
Figure 3.8-11. Three large pieces of debris from the panel face sheet were lodged within the hollow area behind the RCC panel.
