REPORT OF APOLLO 204 REVIEW BOARD

NATIONAL AERONAUTICS AND SPACE ADMINISTRATION

APPENDIX D

PANELS 1 thru 4

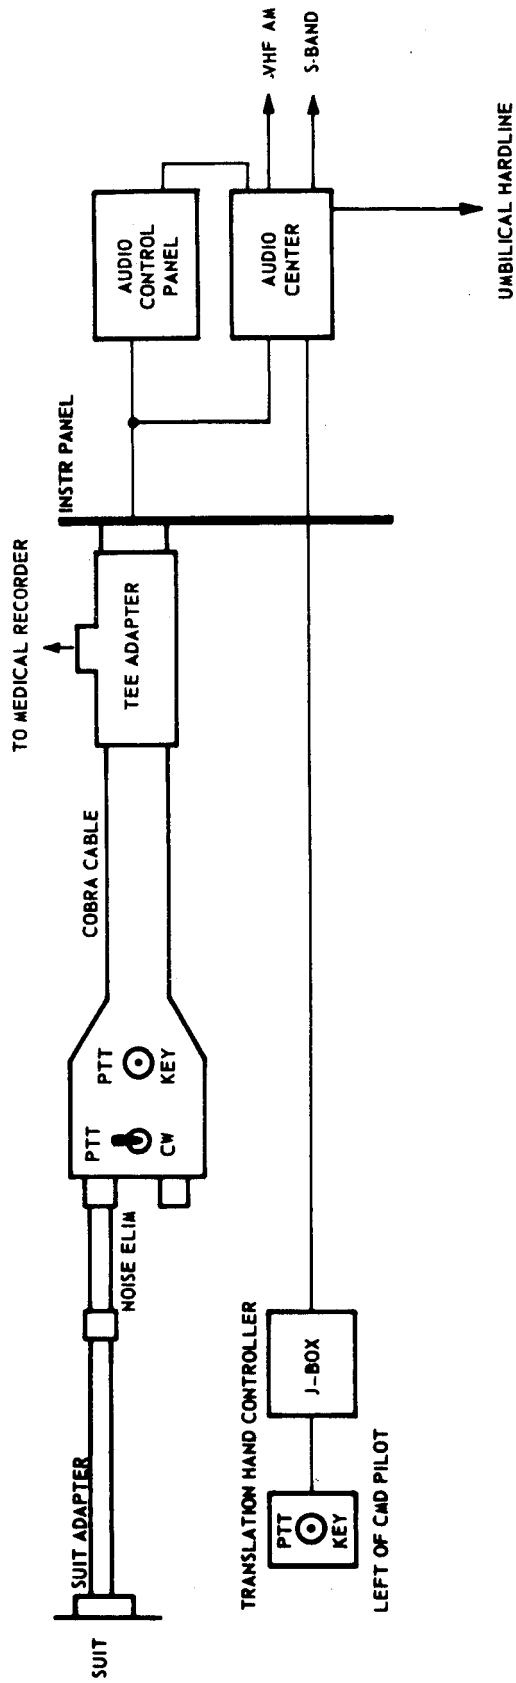
FIG. 4.7-1

- (a). Only one data storage electronic assembly voice recorder (DSEA) was installed, but was not electrically connected. Two DSEA's are required for launch configuration, with only one connected.
- (b). Only one bio-med tee adapter was installed (SRP position). For flight there would be three.
- (c). CMD Pilot was using a flight-space cobra cable (-51) instead of the normal cable (-41); the cobra cable was changed during the "live mike" troubleshooting.
- (d). Audio control panel and cobra cable switches were in position to facilitate testing as a workaround for the "live mike" problem.
- (e). The USBE was in the "transponder only" mode (power amplifier "off"). The launch configuration transponder power amplifier mode would have been selected at T-10 minutes. Figure 4.7-1 shows the astronaut umbilical communication system cobra cable, tee adapter, etc.

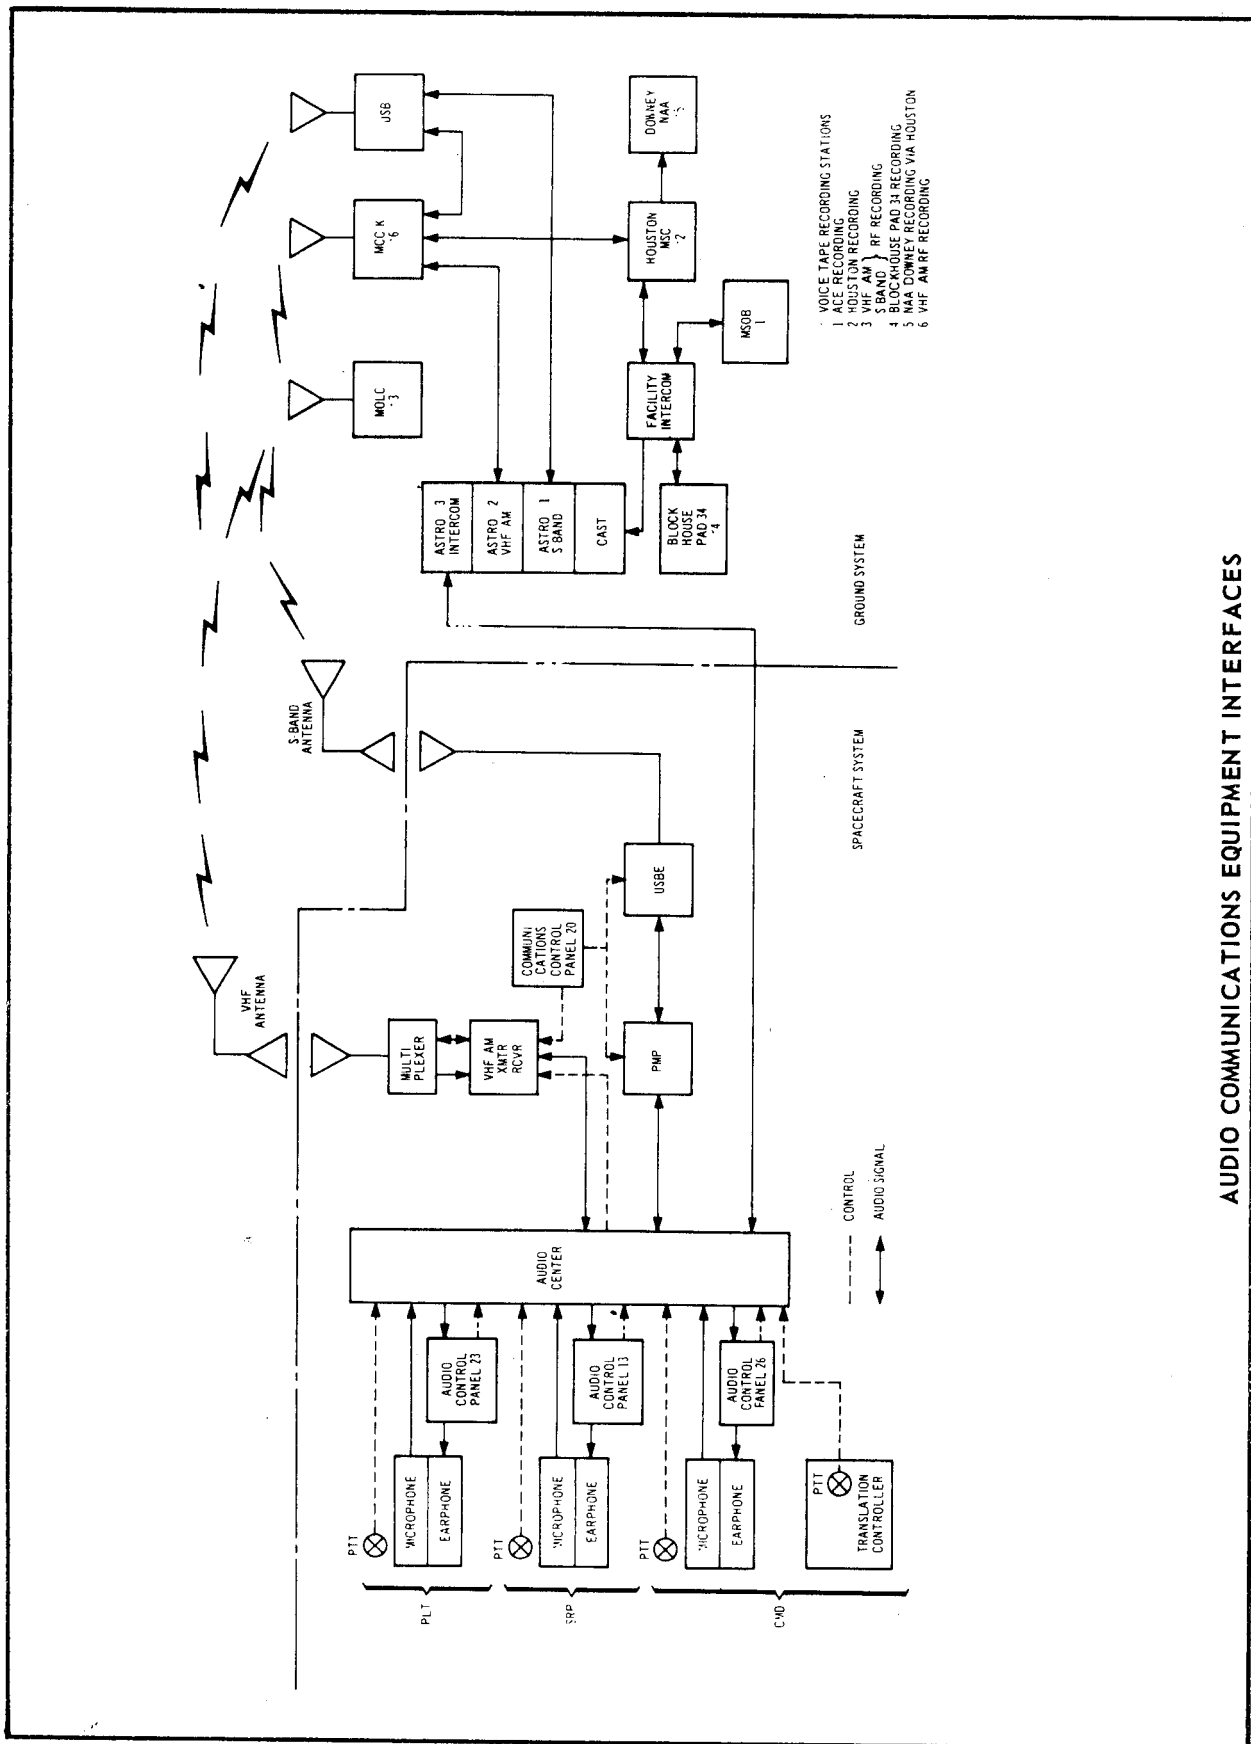
Voice recordings were made in the Manned Spacecraft Operations Building (MSOB) ACE Station, MSOB Open Loop Communication Station (MOLC), Blockhouse 34, MCCK at Cape Kennedy, MSC-Houston, and NAA Downey via Houston (see Figure 4.7-2). The data from these tapes were studied in an attempt to determine possible clues to the cause and crew reaction to the fire. A transcript was made of the S-band and VHF/AM tracks of the MOLC voice tape from 23:29:45.5 GMT to LOS. This tape was chosen because it contained the only direct S-band voice from the S/C and was less noisy than the OIS tapes.
