Other Significant Observations

10.1 PUBLIC SAFETY

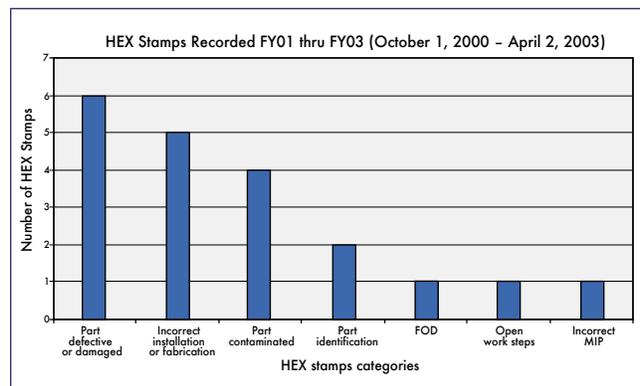
Of the 141,127 inspections subject to rejection from October 2000 through March 2003, only 20 rejections, or "hexes," were recorded, resulting in a statistically improbable discrepancy rate of .014 percent (see Figure 10.4-4). In interviews, technicians and inspectors alike confirmed the dubiousness of this rate. NASA's published rejection rate therefore indicates either inadequate documentation or an underused system. Testimony further revealed incidents of quality assurance inspectors being played against each other to accept work that had originally been refused.

Figure 10.4-4. Rejection, or "Hex" stamps issued from October 2000 through April 2003.
