# Accident Analysis

## 3.1 THE PHYSICAL CAUSE

The physical cause of the loss of *Columbia* and its crew was a breach in the Thermal Protection System on the leading edge of the left wing. The breach was initiated by a piece of insulating foam that separated from the left bipod ramp of the External Tank and struck the wing in the vicinity of the lower half of Reinforced Carbon-Carbon panel 8 at 81.9 seconds after launch. During re-entry, this breach in the Thermal

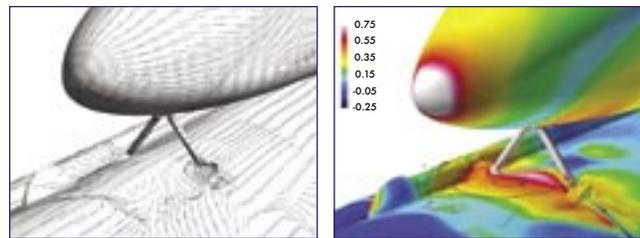
Significant analytical advancements have been made since the External Tank was first conceived, particularly in computational fluid dynamics (see Figure 3.2-5). Computational fluid dynamics comprises a computer-generated model that represents a system or device and uses fluid-flow physics and software to create predictions of flow behavior, and stress or deformation of solid structures. However, analysis must always be verified by test and/or flight data. The External Tank and the bipod ramp were not tested in the complex flight environment, nor were fully instrumented External Tanks ever launched to gather data for verifying analytical tools. The accuracy of the analytical tools used to simulate the External Tank and bipod ramp were verified only by using flight and test data from other Space Shuttle regions.

*Figure 3.2-5. Computational Fluid Dynamics was used to understand the complex flow fields and pressure coefficients around bipod strut. The flight conditions shown here approximate those present when the left bipod foam ramp was lost from External Tank 93 at Mach 2.46 at a 2.08-degree angle of attack.*

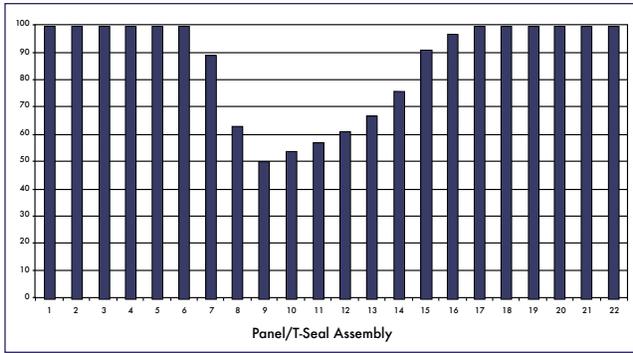
For the first five missions of *Columbia*, the RCC components were not coated with Type A sealant, and had shorter mission service lives than the RCC components on the other Orbiters. (*Columbia*'s panel 9 has the shortest mission service life of 50 flights as shown in Figure 3.3-4.) The predicted life for panel/T-seals 7 through 16 range from 54 to 97 flights.<sup>7</sup>

Figure 3.3-4. The expected mission life for each of the wing leading edge RCC panels on Columbia. Note that panel 9 has the shortest life expectancy.

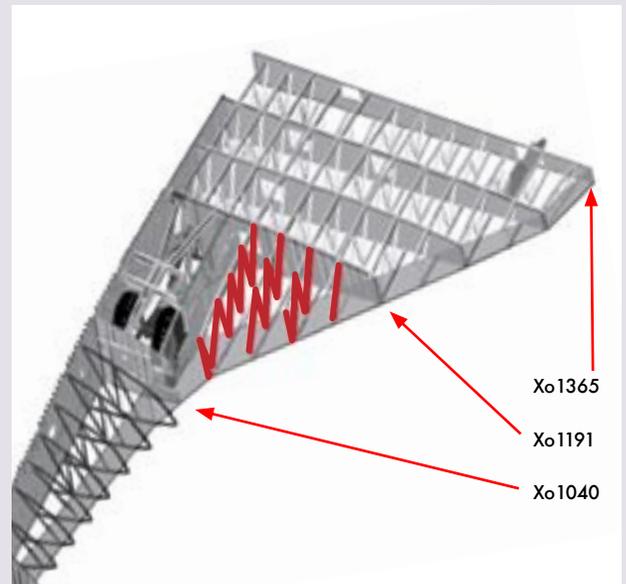
The major internal support structures in the mid-wing are constructed from aluminum alloy. Since aluminum melts at 1,200 degrees Fahrenheit, it is likely these truss tubes in the mid-wing were destroyed and wing structural integrity was lost.

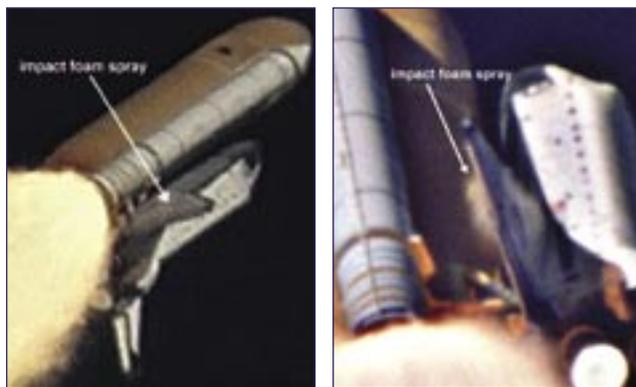
Figure 3.4-1 (color enhanced and "de-blurred" by Lockheed Martin Gaithersburg) and Figure 3.4-2 (processed by the National Imagery and Mapping Agency) are samples of the type of visual data used to establish the time of the impact (81.9 seconds), the altitude at which it occurred (65,860 feet), and the object's relative velocity at impact (about 545 mph relative to the Orbiter).

A 35-mm film camera, E212, which recorded the foam strike from 17 miles away, and video camera E208, which recorded it from 26 miles away, provided the best of the available evidence. Analysis of this visual evidence (see Figures 3.4-1 and 3.4-2) along with computer-aided design analysis, refined the potential impact area to less than 20 square feet in RCC panels 6 through 9 (see Figure 3.4-3), including a portion of the corresponding carrier panels and adjacent tiles. The investigation image analysis team found no conclusive visual evidence of post-impact debris flowing over the top of the wing.

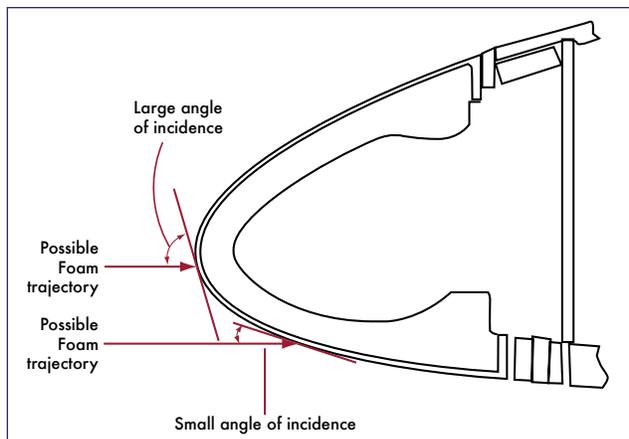
Image analysis determined that the foam was moving almost parallel to the Orbiter's fuselage at impact, with about a five-degree angle upward toward the bottom of the wing and slight motion in the outboard direction. If the foam had hit the tiles adjacent to the leading edge, the angle of incidence would have been about five degrees (the angle of incidence is the angle between the relative velocity of the projectile and the plane of the impacted surface). Because the wing leading edge curves, the angle of incidence increases as the point of impact approaches the apex of an RCC panel. Image and transport analyses estimated that for impact on RCC panel 8, the angle of incidence was between 10 and 20 degrees (see Figure 3.4-4).<sup>9</sup> Because the total force delivered by the impact depends on the angle of incidence, a foam strike near the apex of an RCC panel could have delivered about twice the force as an impact close to the base of the panel.

*Figure 3.4-4. This drawing shows the curve of the wing leading edge and illustrates the difference the angle of incidence has on the effect of the foam strike.*

The precise impact location of the foam determined the impact angle because the debris was moving almost parallel to the Orbiter's fuselage at impact. Tile areas would have been hit at very small angles (approximately five degrees), but the curvature of the leading edge created angles closer to 20 degrees (see Figure 3.4-4).

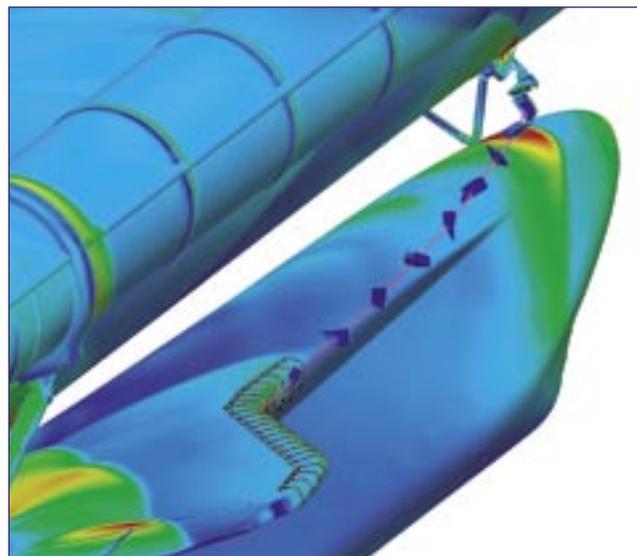
Figure 3.4-6. These are the results of a trajectory analysis that used a computational fluid dynamics approach in a program called CART-3D, a comprehensive (six-degree-of-freedom) computer simulation based on the laws of physics. This analysis used the aerodynamic and mass properties of bipod ramp foam, coupled with the complex flow field during ascent, to determine the likely position and velocity histories of the foam.

The undetermined and yet certainly irregular shape of the foam introduced substantial uncertainty about its estimated aerodynamic characteristics. Appendix D.8 contains an independent analysis conducted by the Board to confirm that the estimated range of ballistic coefficients of the foam in Figure 3.4-6 was credible, given the foam dimension results from the image analyses and the expected range of the foam density. Based on the results in Figure 3.4-7, the physical dimensions of the bipod ramp, and the sizes and shapes of the available barrels for the compressed-gas gun used in the impact test program described later in this chapter, the Board and the NASA Accident Investigation Team decided that a foam projectile 19 inches by 11.5 inches by 5.5 inches, weighing 1.67 pounds, and with a weight density of 2.4 pounds per cubic foot, would best represent the piece of foam that separated from the External Tank bipod ramp and was hit by the Orbiter’s left wing. See Section 3.8 for a full discussion of the foam impact testing.

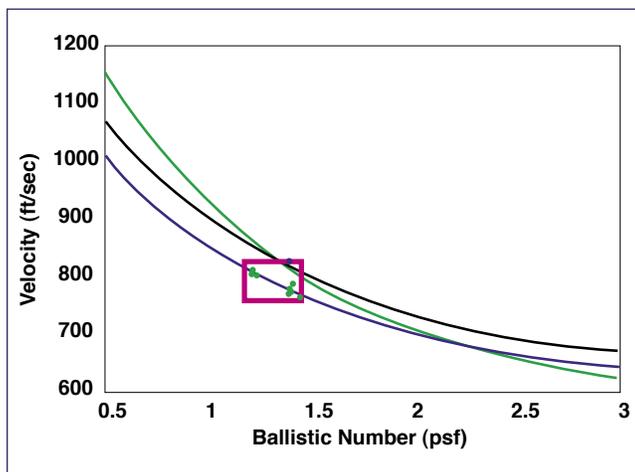
Figure 3.4-7. The results of numerous possible trajectories based on various assumed sizes, shapes, and densities of the foam. Either the foam had a slightly higher ballistic coefficient and the Orbiter struck the foam at a lower speed relative to the Orbiter, or the foam was more compact and the wing struck the foam at a higher speed. The “best fit” box represents the overlay of the data from the image analysis with the transport analysis computations. This data enabled a final selection of projectile characteristics for impact testing.

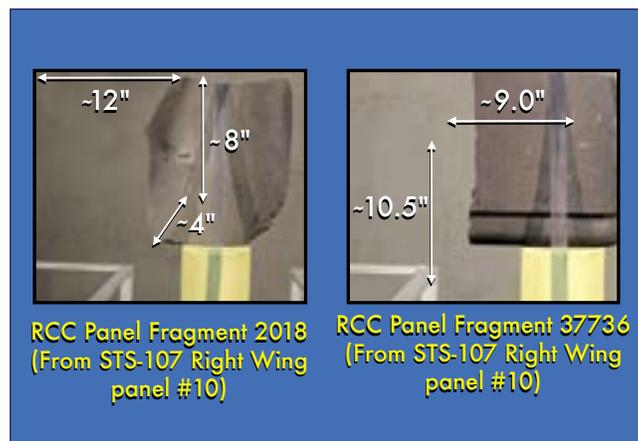
Figure 3.5-1. These representative RCC acreage pieces matched the radar cross-section of the Flight Day 2 object.

In the Advanced Compact Range at the Air Force Research Laboratory in Dayton, Ohio, analysts tested 31 materials from the Orbiter's exterior and payload bay. Additional supercomputer radar cross-section predictions were made for Reinforced Carbon-Carbon T-seals. After exhaustive radar cross-section analysis and testing, coupled with ballistic analysis of the object's orbital decay, only a fragment of RCC panel would match the UHF radar cross-section and ballistic coefficients observed by the Space Surveillance network. Such an RCC panel fragment must be approximately 140 square inches or greater in area to meet the observed radar cross-section characteristics. Figure 3.5-1 shows RCC panel fragments from *Columbia*'s right wing that represent those meeting the observed characteristics of object 2003-003B.<sup>10</sup>

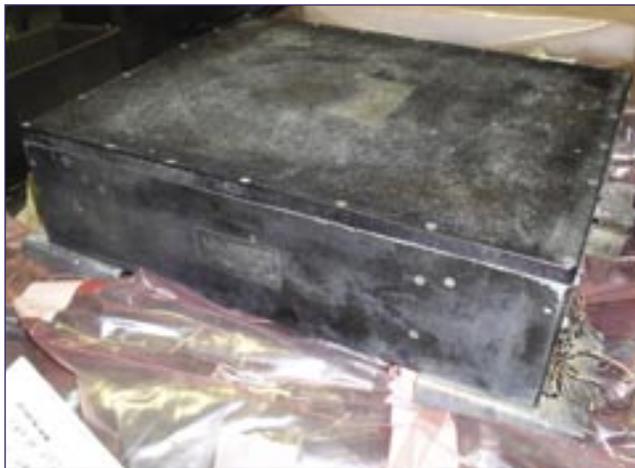
Figure 3.6-1. The Modular Auxiliary Data System recorder, found near Hemphill, Texas. While not designed to withstand impact damage, the recorder was in near-perfect condition when recovered on March 19, 2003.

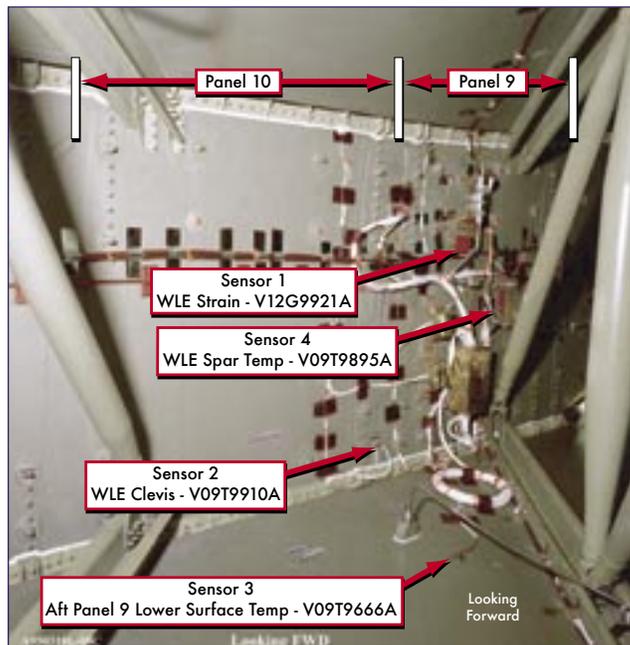
Figure 3.6-2. Location of sensors on the back of the left wing leading edge spar (vertical aluminum structure in picture). Also shown are the round truss tubes and ribs that provided the structural support for the mid-wing in this area.

or outside the wing leading edge spar near Reinforced Carbon-Carbon (RCC) panel 9-left, helped tell the story of what happened on the left wing of the Orbiter early in the re-entry. These four sensors were: strain gauge V12G9921A (Sensor 1), resistance temperature detector V09T9910A on the RCC clevis between panel 9 and 10 (Sensor 2), thermocouple V07T9666A, within a Thermal Protection System tile (Sensor 3), and resistance temperature detector V09T9895A (Sensor 4), located on the back side of the wing leading edge spar behind RCC panels 8 and 9 (see Figure 3.6-2).

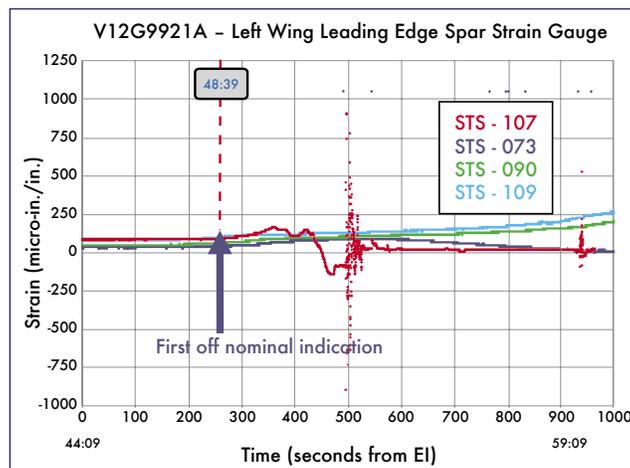
Figure 3.6-3. The strain gauge (Sensor 1) on the back of the left wing leading edge spar was the first sensor to show an anomalous reading. In this chart, and the others that follow, the red line indicates data from STS-107. Data from other *Columbia* re-entries, similar to the STS-107 re-entry profile, are shown in the other colors.

Sensor 1 provided the first anomalous reading (see Figure 3.6-3). From EI+270 to EI+360, the strain is higher than that on previous *Columbia* flights. At EI+450, the strain reverses, and then peaks again in a negative direction at EI+475. The strain then drops slightly, and remains constant and negative until EI+495, when the sensor pattern becomes unreliable, probably due to a propagating soft short, or “burn-through” of the insulation between cable conductors caused by heating or combustion. This strain likely indicates significant damage to the aluminum honeycomb spar. In particular, strain reversals, which are unusual, likely mean there was significant high-temperature damage to the spar during this time.

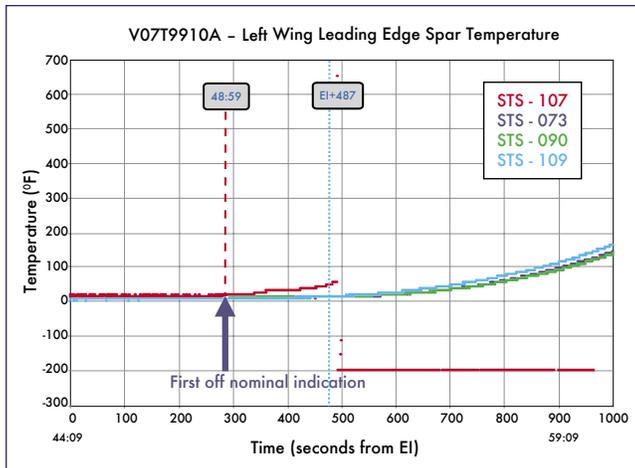
Figure 3.6-4. This temperature thermocouple (Sensor 2) was mounted on the outside of the wing leading edge spar behind the insulation that protects the spar from radiated heat from the RCC panels. It clearly showed an off-nominal trend early in the re-entry sequence and began to show an increase in temperature much earlier than the temperature sensor behind the spar.

left wing leading edge spar, recorded the beginning of a gradual and abnormal rise in temperature from an expected 30 degrees Fahrenheit to 65 degrees at EI+493, when it then dropped to “off-scale low,” a reading that drops off the scale at the low end of the sensor’s range (see Figure 3.6-4). Sensor 2, one of the first to fail, did so abruptly. It had indicated only a mild warming of the RCC attachment clevis before the signal was lost.

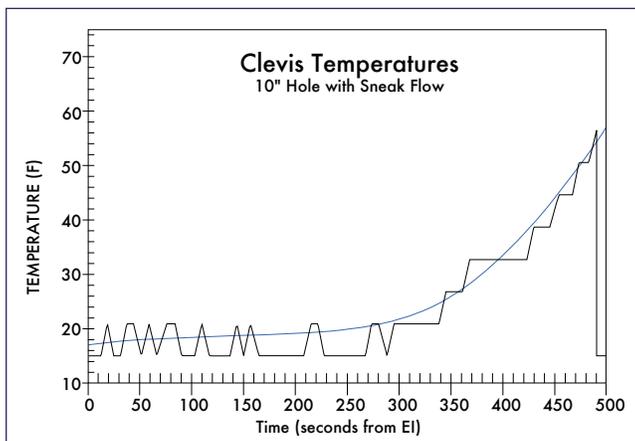
Figure 3.6-5. The analysis of the effect of a 10-inch hole in RCC panel 8 on Sensor 2 from EI to EI+500 seconds. The jagged line shows the actual flight data readings and the smooth line the calculated result for a 10-inch hole with some sneak flow of superheated air behind the spar insulation.

A series of thermal analyses were performed for different sized holes in RCC panel 8 to compute the time required to heat Sensor 2 to the temperature recorded by the Modular Auxiliary Data System. To heat the clevis, various insulators would have to be bypassed with a small amount of leakage, or “sneak flow.” Figure 3.6-5 shows the results of these calculations for, as an example, a 10-inch hole, and demonstrates that with sneak flow around the insulation, the temperature profile of the clevis sensor was closely matched by the engineering calculations. This is consistent with the same sneak flow required to match a similar but abnormal ascent temperature rise of the same sensor, which further supports the premise that the breach in the leading edge of the wing occurred during ascent. While the exact size of the breach will never be known, and may have been smaller or larger than 10 inches, these analyses do provide a plausible explanation for the observed rises in temperature sensor data during re-entry.

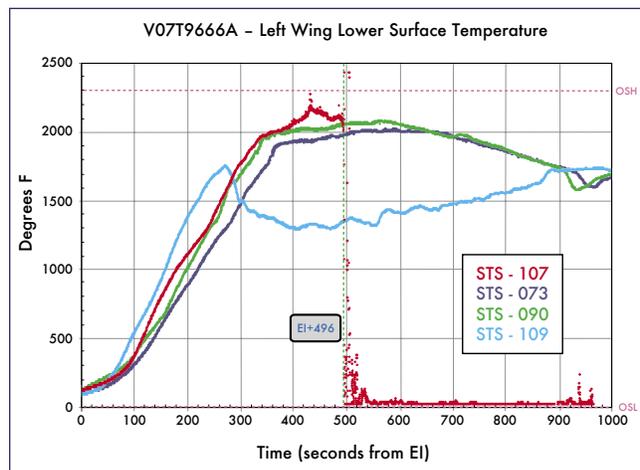
Figure 3.6-6. As early as EI+370, Sensor 3 began reading significantly higher than on previous flights. Since this sensor was located in a thermal tile on the lower surface of the left wing, its temperatures are much higher than those for the other sensors.

The readings of Sensor 3, which was in a thermal tile, began rising abnormally high and somewhat erratically as early as EI+370, with several brief spikes to 2,500 degrees Fahrenheit, significantly higher than the 2,000-degree peak temperature on a normal re-entry (Figure 3.6-6). At EI+496, this reading became unreliable, indicating a failure of the wire or the sensor. Because this thermocouple was on the wing lower surface, directly behind the junction of RCC panel 9 and 10, the high temperatures it initially recorded were almost certainly a result of air jetting through the damaged area of RCC panel 8, or of the normal airflow being disturbed by the damage. Note that Sensor 3 provided an external temperature measurement, while Sensors 2 and 4 provided internal temperature measurements.

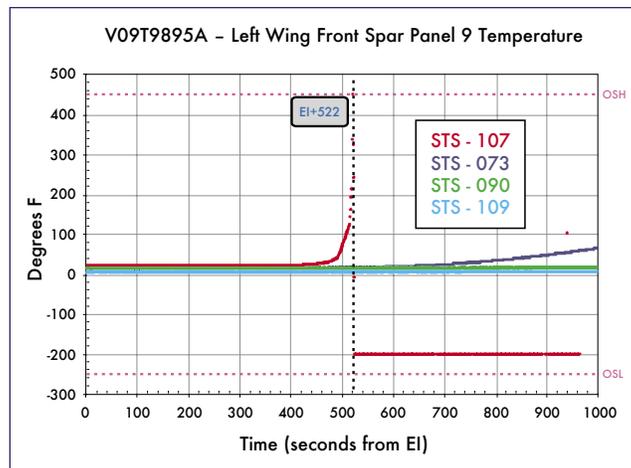
Sensor 4 also recorded a rise in temperature that ended in an abrupt fall to off-scale low. Figure 3.6-7 shows that an abnormal temperature rise began at EI+425 and abruptly fell at EI+525. Unlike Sensor 2, this temperature rise was extreme, from an expected 20 degrees Fahrenheit at EI+425 to 40 degrees at EI+485, and then rising much faster to 120 degrees at EI+515, then to an off-scale high (a reading that climbs off the scale at the high end of the range) of 450 degrees at EI+522. The failure pattern of this sensor likely indicates destruction by extreme heat.

Figure 3.6-7. Sensor 4 also began reading significantly higher than previous flights before it fell off-scale low. The relatively late reaction of this sensor compared to Sensor 2, clearly indicated that superheated air started on the outside of the wing leading edge spar and then moved into the mid-wing after the spar was burned through. Note that immediately before the sensor (or the wire) fails, the temperature is at 450 degrees Fahrenheit and climbing rapidly. It was the only temperature sensor that showed this pattern.

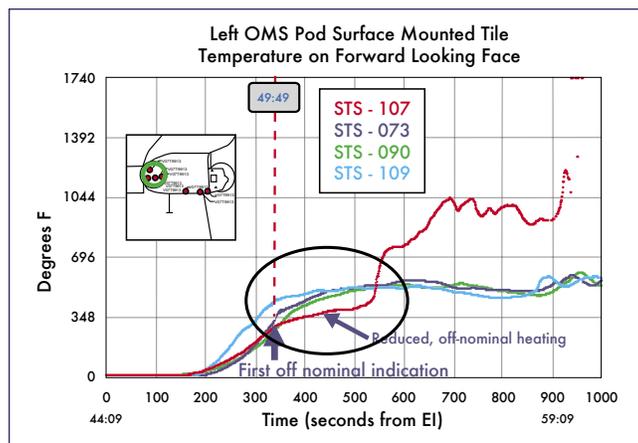
Figure 3.6-9. Orbital Maneuvering System (OMS) pod heating was initially significantly lower than that seen on previous Columbia missions. As wing leading edge damage later increased, the OMS pod heating increased dramatically. Debris recovered from this area of the OMS pod showed substantial pre-breakup heat damage and imbedded drops of once-molten metal from the wing leading edge in the OMS pod thermal tiles.

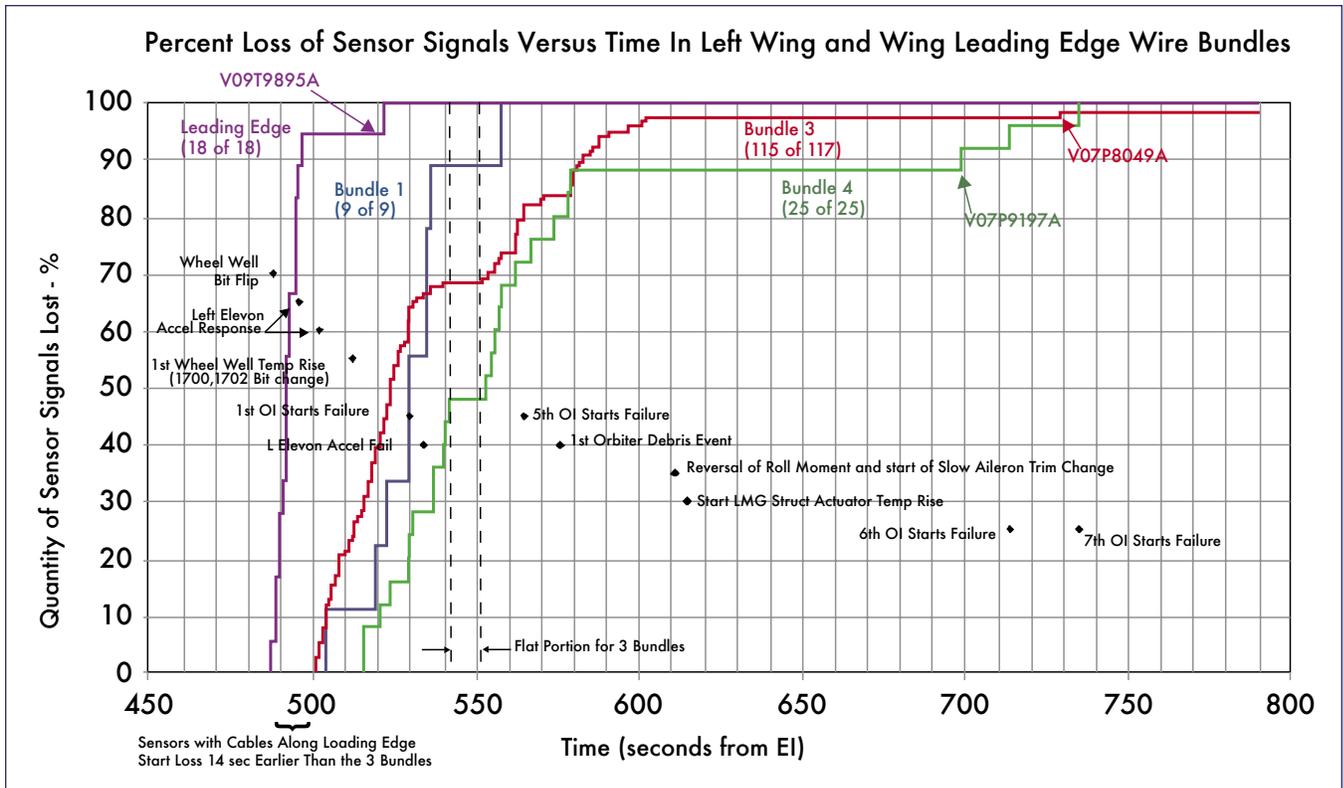
Fourteen seconds after the loss of the first sensor wire on the wing leading edge spar at EI+487, a sensor wire in a bundle of some 150 wires that ran along the upper outside corner of the left wheel well showed a burn-through. In the next 50 seconds, more than 70 percent of the sensor wires in three cables in this area also burned through (see Figure 3.6-10). Investigators plotted the wiring run for every left-wing sensor, looking for a relationship between their location and time of failure.

Figure 3.6-10. This chart shows how rapidly the wire bundles in the left wing were destroyed. Over 70 percent of the sensor wires in the wiring bundles burned through in under a minute. The black diamonds show the times of significant timeline sensor events.

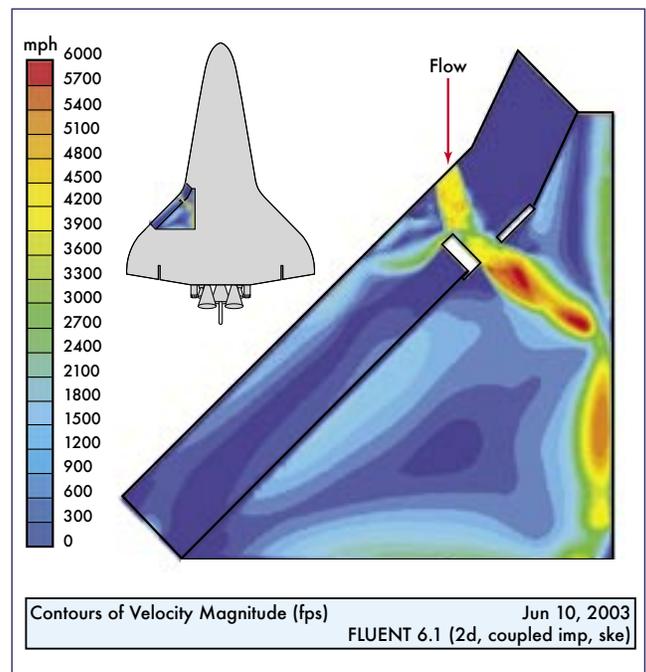
Later computational fluid dynamics analysis of the mid-wing area behind the spar showed that superheated air flowing into a breached RCC panel 8 and then interacting with the internal structure behind the RCC cavity (RCC ribs and spar insulation) would have continued through the wing leading edge spar as a jet, and would have easily allowed superheated air to traverse the 56.5 inches from the spar to the outside of the wheel well and destroy the cables (Figure 3.6-11). Controllers on the ground saw these first anomalies in the telemetry data at EI+613, when four hydraulic sensor cables that ran from the aft part of the left wing through the wiring bundles outside the wheel well failed.

Figure 3.6-11. The computational fluid dynamics analysis of the speed of the superheated air as it entered the breach in RCC panel 8 and then traveled through the wing leading edge spar. The darkest red color indicates speeds of over 4,000 miles per hour. Temperatures in this area likely exceeded 5,000 degrees Fahrenheit. The area of detail is looking down at the top of the left wing.

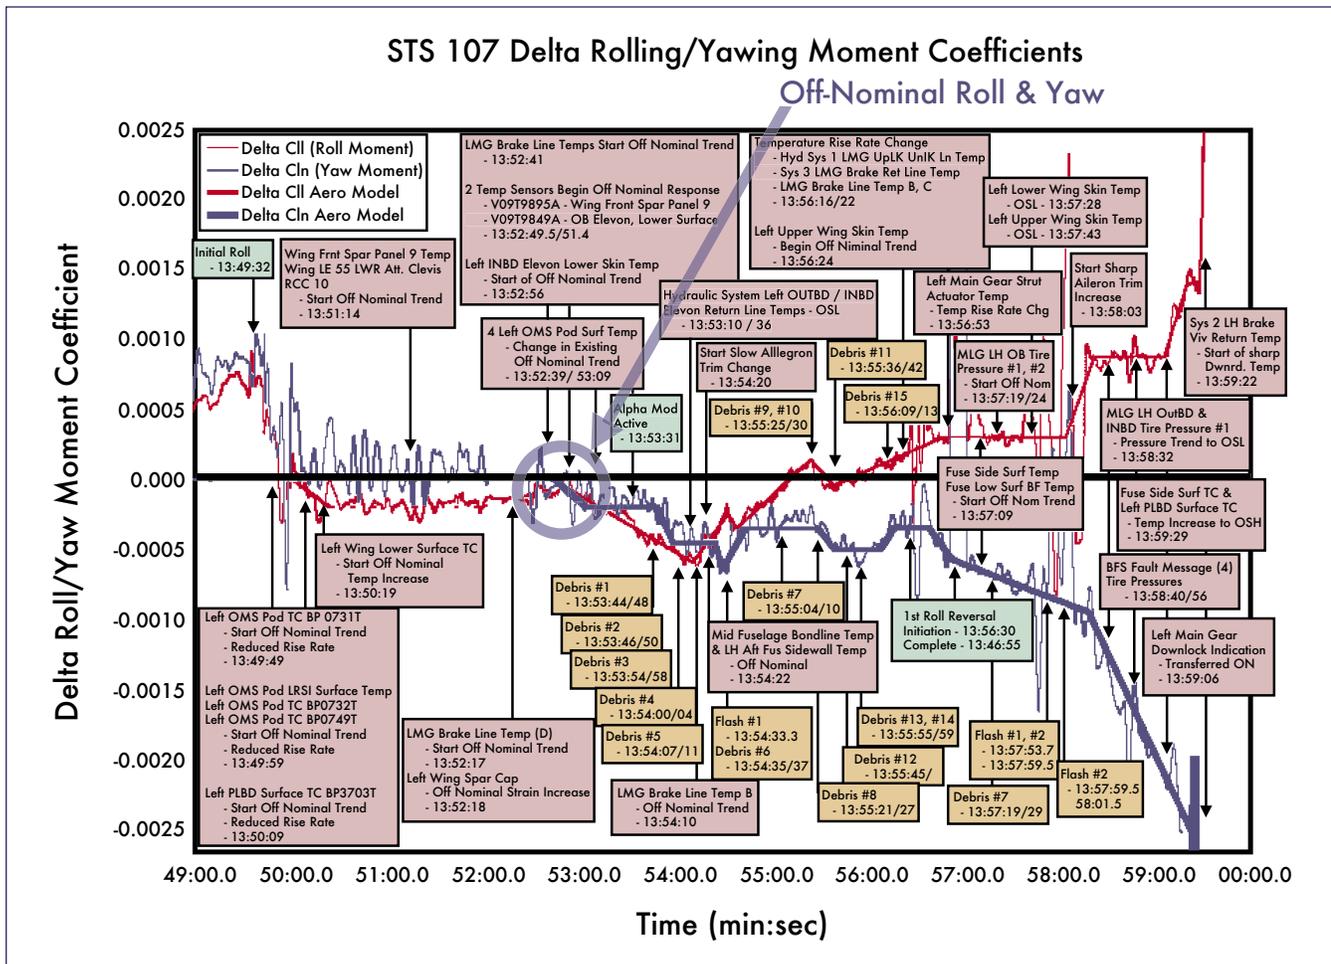
Aerodynamic roll and yaw forces began to differ from those on previous flights at about EI+500 (see Figure 3.6-12). Investigators used flight data to reconstruct the aerodynamic forces acting on the Orbiter. This reconstructed data was then compared to forces seen on other similar flights of *Columbia*

Figure 3.6-12. At approximately EI+500 seconds, the aerodynamic roll and yaw forces began to diverge from those observed on previous flights. The blue line shows the Orbiter's tendency to yaw while the red line shows its tendency to roll. Nominal values would parallel the solid black line. Above the black line, the direction of the force is to the right, while below the black line, the force is to the left.

and to the forces predicted for STS-107. In the early phase of flight, these abnormal aerodynamic forces indicated that *Columbia's* flight control system was reacting to a change in the external shape of the wing, which was caused by progressive RCC damage that caused a continuing decrease in lift and a continuing increase in drag on the left wing.

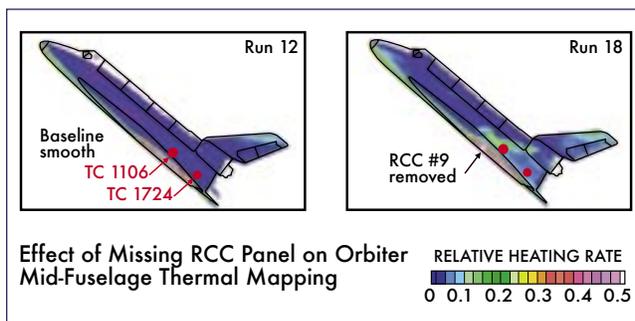
Figure 3.6-13 shows the comparison of surface temperature distribution with an undamaged Orbiter and one with an entire panel 9 removed. With panel 9 removed, a strong vortex flow structure is positioned to increase the temperature on the leading edge of the Orbital Maneuvering System pod. The aim is not to demonstrate that all of panel 9 was missing at this point, but rather to indicate that major damage to panels near panel 9 can shift the strong vortex flow pattern and change the Orbiter's temperature distribution to match the Modular Auxiliary Data System information. Wind tunnel tests also demonstrated that increasing damage to leading edge RCC panels would result in increasing drag and decreasing lift on the left wing.

Figure 3.6-13. The effects of removing RCC panel 9 are shown in this figure. Note the brighter colors on the front of the OMS pod show increased heating, a phenomenon supported by both the OMS pod temperature sensors and the debris analysis.

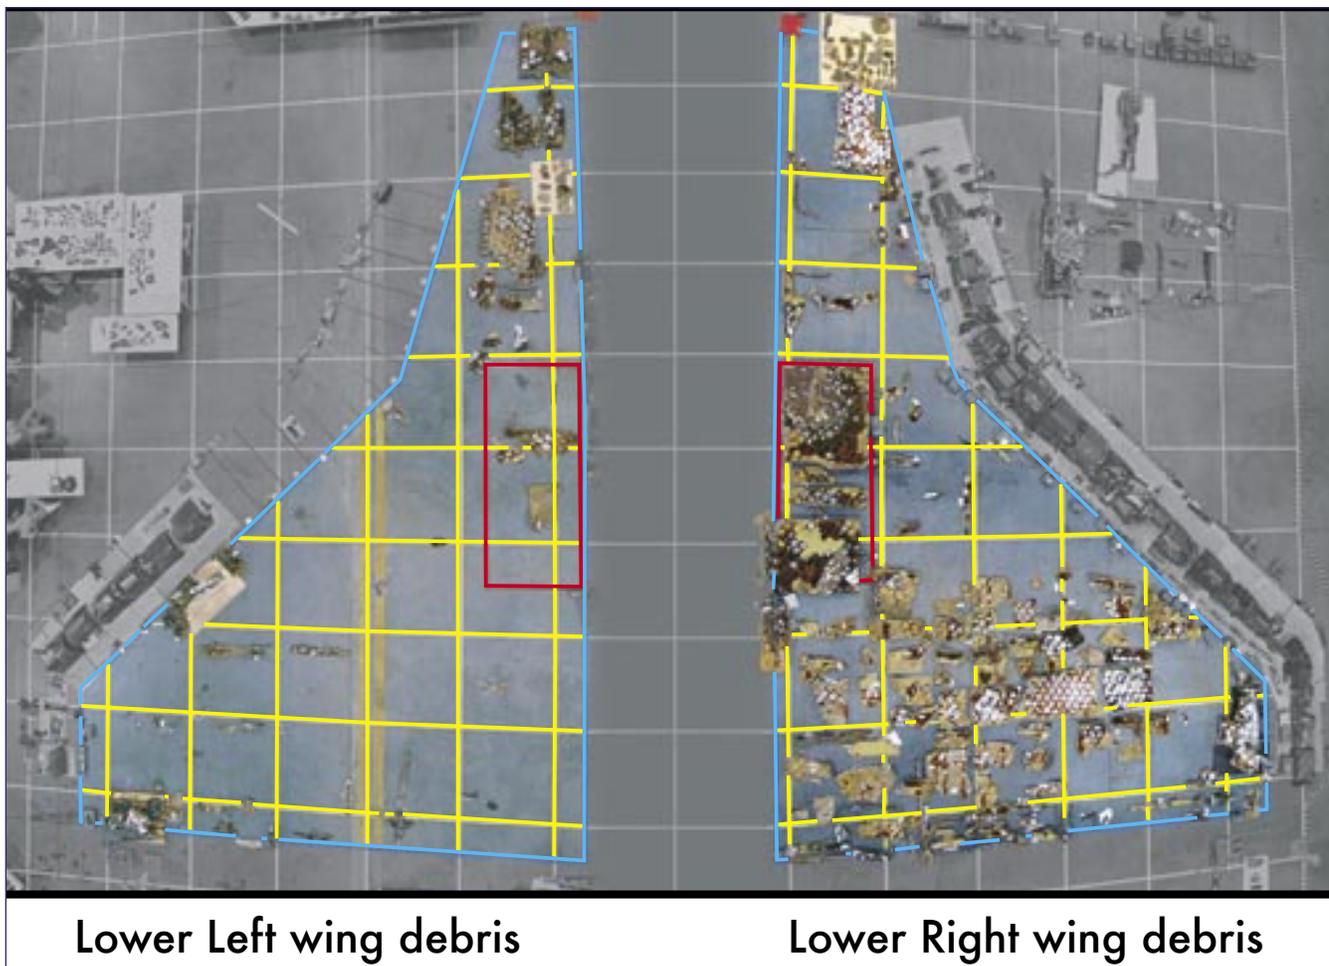
Figure 3.7-1. Comparison of amount of debris recovered from the left and right wings of Columbia. Note the amount of debris recovered from areas in front of the wheel well (the red boxes on each wing) were similar, but there were dramatic differences in the amount of debris recovered aft of each wheel well.

Detailed analysis of the debris revealed unique features and convincing evidence that the damage to the left wing differed significantly from damage to the right, and that significant differences existed in pieces from various areas of the left wing. While a substantial amount of upper and lower right wing structure was recovered, comparatively little of the upper and lower left wing structure was recovered (see Figure 3.7-1).

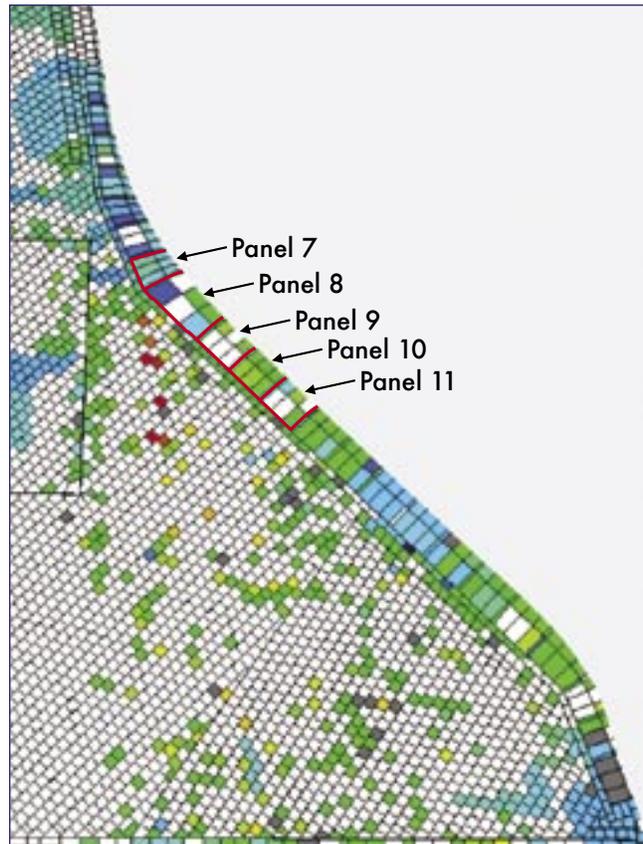
Figure 3.7-6. The tiles recovered farthest west all came from the area immediately behind left wing RCC panels 8 and 9. In the figure, each small box represents an individual tile on the lower surface of the left wing. The more red an individual tile appears, the farther west it was found.

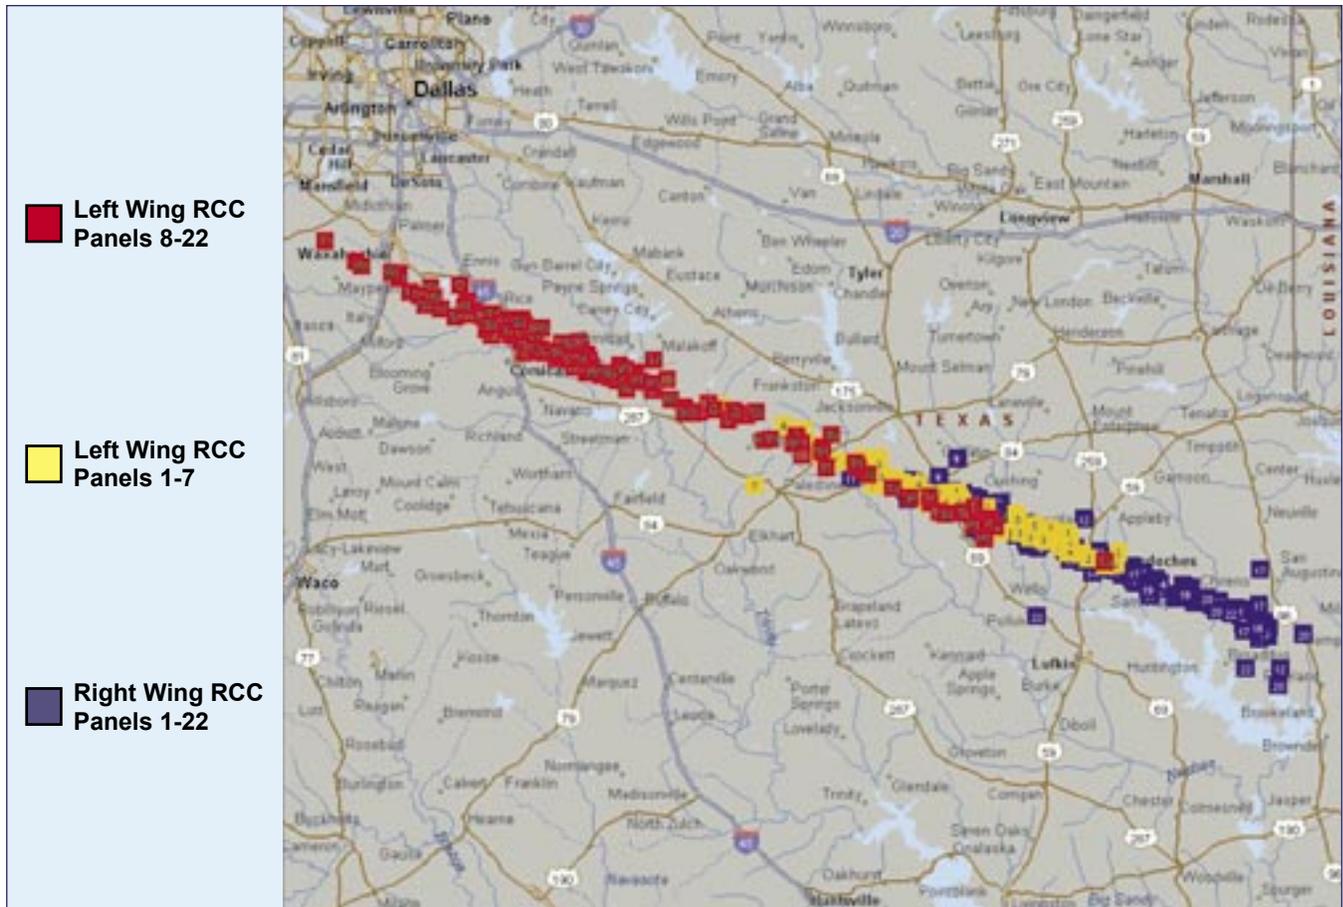
The location of debris on the ground also provided evidence of where the initial breach occurred. The location of every piece of recovered RCC was plotted on a map and labeled according to the panel the piece originally came from. Two distinct patterns were immediately evident. First, it was clear that pieces from left wing RCC panels 9 through 22 had fallen the farthest west, and that RCC from left wing panels 1 through 7 had fallen considerably farther east (see Figure 3.7-5). Second, pieces from left wing panel 8 were

Figure 3.7-5. The location of RCC panel debris from the left and right wings, shown where it was recovered from in East Texas. The debris pattern suggested that the left wing failed before the right wing, most likely near left RCC panels 8 and 9.

found throughout the debris field, which suggested that the left wing likely failed in the vicinity of RCC panel 8. The early loss of the left wing from RCC panel 9 and outboard caused the RCC from that area to be deposited well west of the RCC from the inboard part of the wing. Since panels 1 through 7 were so much farther to the east, investigators concluded that RCC panels 1 through 7 had stayed with the Orbiter longer than had panels 8 through 22.

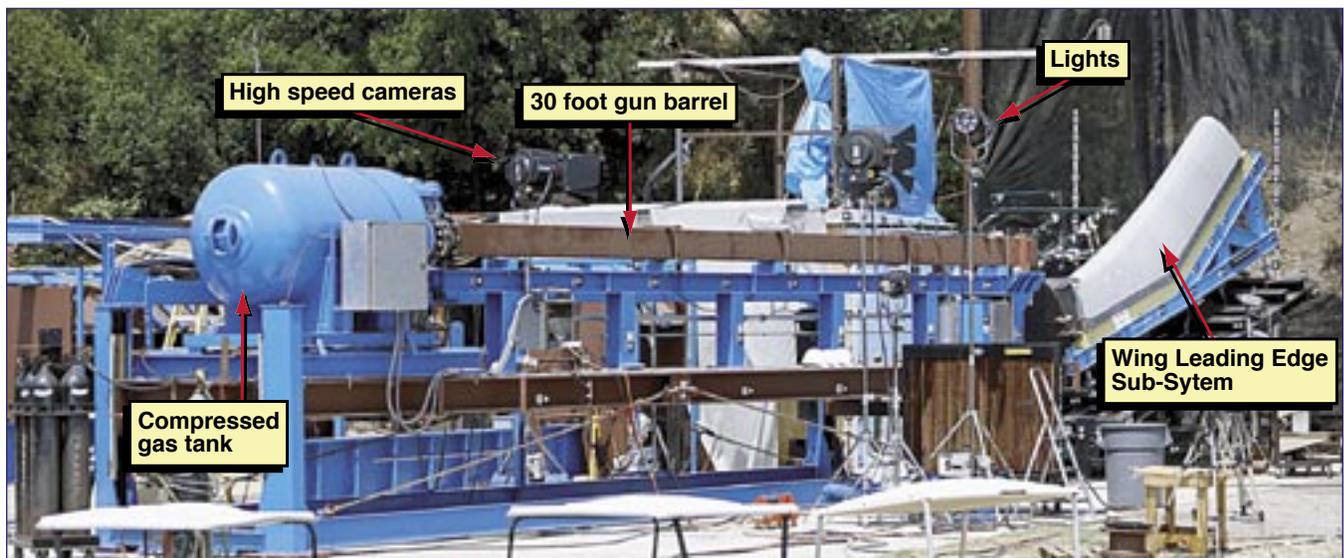
Figure 3.8-1. Nitrogen-powered gun at the Southwest Research Institute used for the test series.

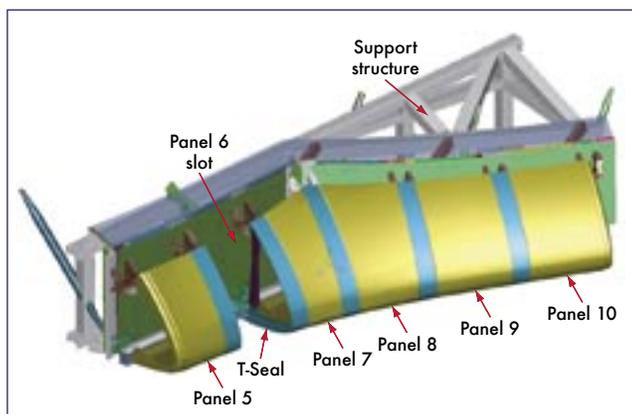
Figure 3.8-2. Test assembly that provided a structural mounting for RCC panel assemblies 5 to 10 and would accommodate some 200 sensors and other test equipment.

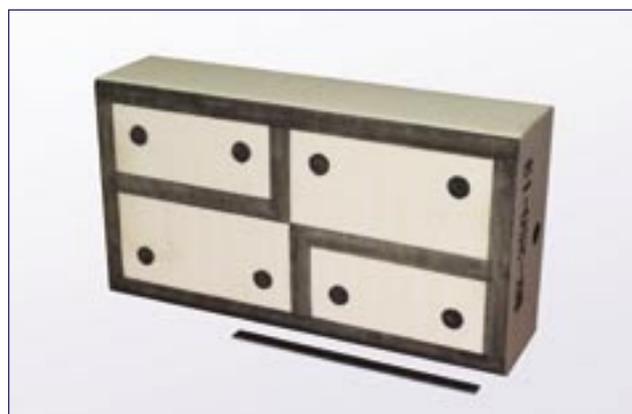
Figure 3.8-3. A typical foam projectile, which has marks for determining position and velocity as well as blacked outlines for indicating the impact footprint.

The testing required a projectile (see Figure 3.8-3) made from standard stock, so investigators selected a rectangular cross-section of 11.5 by 5.5 inches, which was within 15 percent of the footprint of the mean debris size initially estimated by image analysis. To account for the foam's density, the projectile length was cut to weigh 1.67 pounds, a figure determined by image and transport analysis to best represent the STS-107 projectile. For foam with a density of 2.4 pounds per cubic foot,<sup>15</sup> the projectile dimensions were 19 inches by 11.5 inches by 5.5 inches.

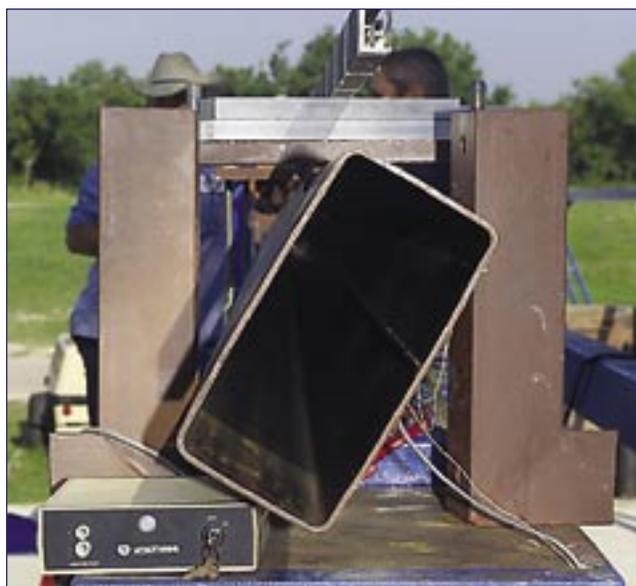
The "clocking angle" was an additional consideration. As shown in Figure 3.8-4, the gun barrel could be rotated to change the impact point of the foam projectile on the leading edge. Investigators conducted experiments to determine if the corner of the foam block or the full edge would impart a

Figure 3.8-4. The barrel on the nitrogen gun could be rotated to adjust the impact point of the foam projectile.

greater force. During the fiberglass tests, it was found that a clocking angle of 30 degrees allowed the 11.5-inch-edge to fully contact the panel at impact, resulting in a greater local force than a zero degree angle, which was achieved with the barrel aligned vertically. A zero-degree angle was used for the test on RCC panel 6, and a 30-degree angle was used for RCC panel 8.

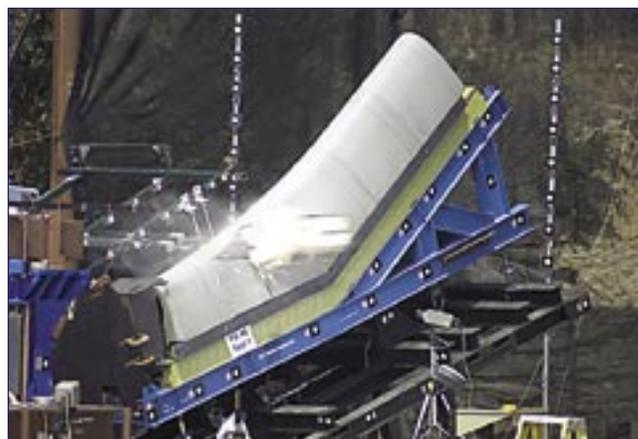
Five engineering tests on fiberglass panels (see Figure 3.8-5) established the test parameters of the impact tests on RCC panels. Details of the fiberglass tests are in Appendix D.12.

Figure 3.8-5. A typical foam strike leaves impact streaks, and the foam projectile breaks into shards and larger pieces. Here the foam is striking Panel 6 on a fiberglass test article.
